Manhole Inspection Summary

Manhole # S27C1_006MH

Insp Date: **4/15/08 1:55 PM**

Location Address: **WENBURN ST.**

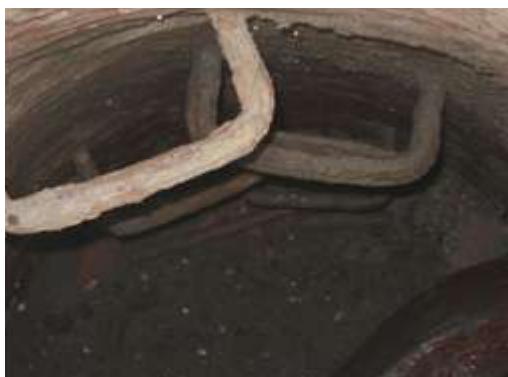
Defect 3

Steps Count: **4** Missing: **0** ☒ **Corroded**

CORRODED STEPS AND DEBRIS ON BENCH

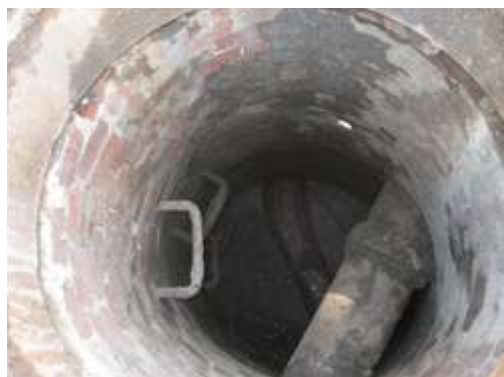
Defect 4

Condition: ☐ Sound ☐ Cracked ☐ Root Intrusion ☐ Loose Brick ☒ **Deteriorated**

deteriorated chimney and corbel

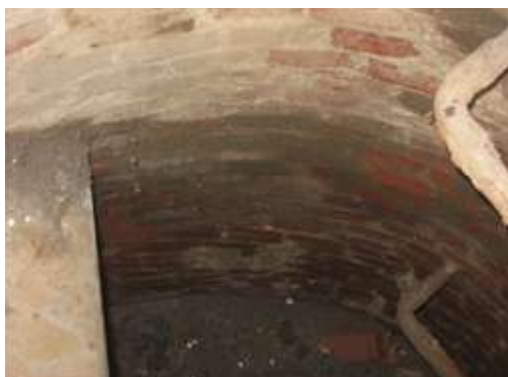
Defect 2

Surcharge ☒ **Evidence Of Surcharge** Depth: **2** (ft.) ☐ Active Surcharge Present

Evidence of Surcharge

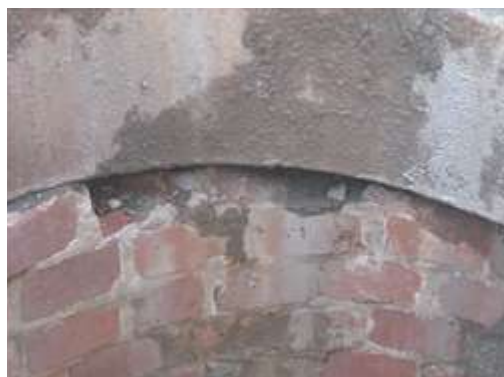
Defect 1

Condition: ☐ Sound ☒ **Cracked** ☐ Root Intrusion ☒ **Loose Brick** ☒ **Deteriorated**

Infiltration: ☐ None ☒ **Joint** ☐ Cracks ☒ **Mortar** ☐ Roots ☐ Wall

Cracked, Loose Bricks and Deterioration in Chimney, Chimney Infiltration and missing mortar

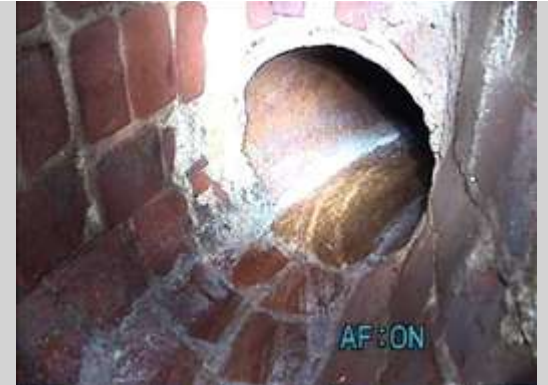
12 O'Clock Outflow

Pipe Height: **8.4** (in.) Rod and Bar (Angled)
Pipe Material: **Clay** ☐ Pipe Lined
Invert Depth: **10.42** (ft.) Flow Characteristics: **Slow**
Deposits: ☒ None ☐ Mud ☐ Sludge ☐ Debris ☐ Grease
Silt Depth: **0** (in.) Deposits Extent:
Infiltration: **None** Pipe Seal Cond: **Sound**

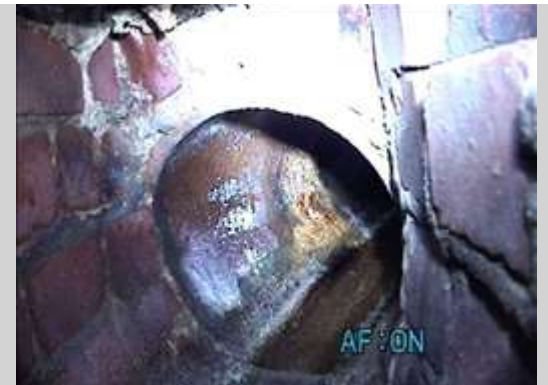
5 O'Clock Inflow

Pipe Height: **8.4** (in.) Rod and Bar (Angled)
Pipe Material: **Clay** ☐ Pipe Lined
Invert Depth: **9.95** (ft.) Flow Characteristics: **Slow**
Deposits: ☒ None ☐ Mud ☐ Sludge ☐ Debris ☐ Grease
Silt Depth: **0** (in.) Deposits Extent:
Infiltration: **None** Pipe Seal Cond: **Sound**
